#### IOWA BRAILLE AND SIGHT SAVING SCHOOL STORM RECOVERY

### <u>Iowa Braille and Sight Saving School</u> Facility Restoration Recommendations

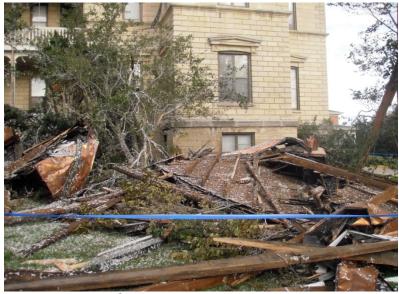
Picture 1 depicts Old Main building debris.

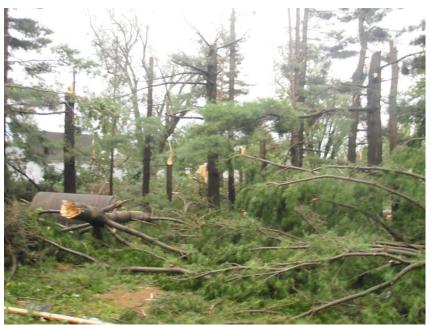
Picture 2 depicts grounds debris

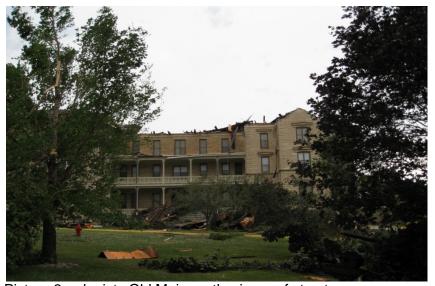
Picture 3 – depicts Old Main north wing roof structure

The largest campus building is Old Main, a four story facility (basement and 3 upper floors), with building area of 87,700 gross square feet. Old Main sustained the most significant damage with the complete loss of standing seam copper metal roof and supporting wood frame structure on the north and south wings. Additional damage was sustained to sheet metal soffit, masonry parapet walls, the north and south gable end masonry walls, the center building roof section, and to the attic fire protection system, mechanical systems and electrical systems. Interior building damage occurred due to water that infiltrated the building and fire protection water from the attic sprinkler system. Debris from the roof damage entered the elevator shaft causing loss of elevator use. Picture 4 illustrates the near total destruction of the Old Main exposed roof and underlying wood structure on the north and south of the building.

Iowa State University Facilities Planning and Management worked with HR Green engineering firm to conduct a feasibility study of options and approximate project costs for the roof restoration of Old Main. HR Green estimated the project costs to restore Old Main roof and roof structure to pre-storm conditions to be \$3,002,000.

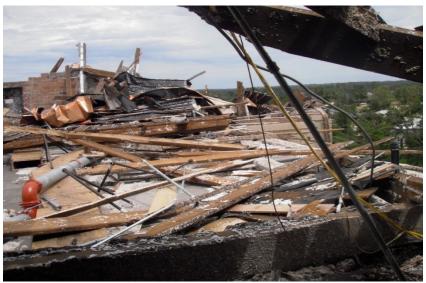
Picture 4– depicts the north wing from on top of the roof

During the initial emergency response to the Old Main damage, a rubber roof membrane was placed over the exposed roof deck areas to minimize rain infiltration into the building. At the current time, an emergency construction project is underway to install a temporary vented membrane roof system over the Old Main roof area to provide weather protection to the remaining attic spaces and interior areas below.
